# Florida Water Resources JOURNAL

December 2020

# Proactive Emergency: Replacing Daytona Beach's Most Critical Water Pipe

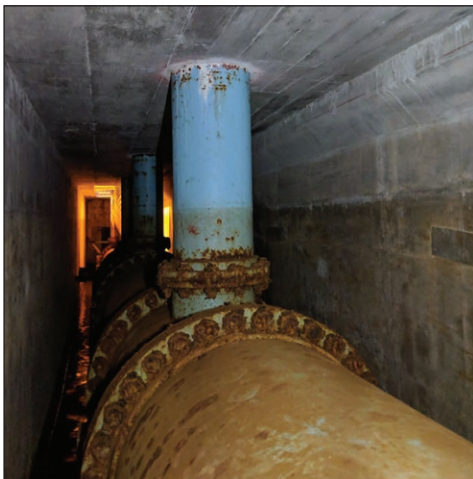
The City of Daytona Beach (city) identified a critical 45-year-old finished water discharge header pipe, which manifolds the high-service pumps (HSPs), as shown in Figure 1, that provide all water to the city via its sole WTP.

Figure 1. Discharge header pipe tunnel.

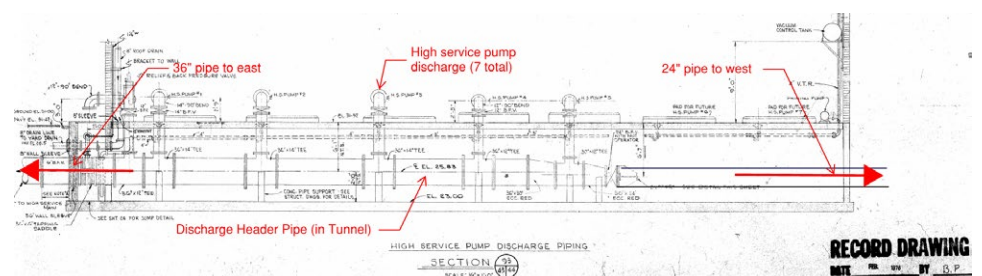
Figure 2. Discharge header pipe record drawing.

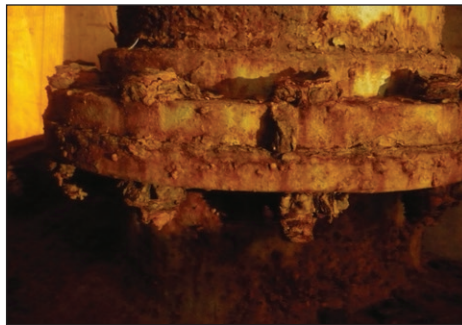
Located in a humid tunnel (Figure 1), the exterior of the 36-in. pipe became heavily corroded over its 45-year life span (Figure 3), posing a greater failure risk. Upon an operator inspection of the high-service pump station (HSPS) discharge header, the city decided to further evaluate the pipe, which ultimately led to identifying reliability improvements to the HSPS discharge header. Because it's critical to maintain operation of the pump station (and the pipe) to provide supply to the city, the project was viewed as critical and placed on a rapid schedule.

- ◆ The 45-year-old DIP had excellent wall thickness results.
- ◆ There were no leaks.
- ◆ The exterior was highly corroded, believed to be due mainly to the initial design and environment, which created a humidity trap and sweating pipe.
- ◆ Flange bolts were heavily corroded and significantly deteriorated.
- ◆ “Line taps” that included corroded galvanized pipe posed a risk of failure.
- ◆ Air release valves were installed on steel saddles, with couplings that were highly corroded.
- ◆ Only one valve was installed in-line and was inoperable.

Figure 3. Corroded flange and bolts from a high-service pipe into a header.

environment for high corrosion potential on the pipe. With the bolts and tapping saddles showing the greatest corrosion, along with a lack of operational valves in the header, it was determined to replace the entire “exposed” header that existed within the tunnel. The exterior buried pipe was anticipated to be in

The team considered potential ways to isolate sections of the pipe, but safe accessibility remained a major issue that could not be resolved. Thus, it was determined that replacement of the header pipe would be the safer, lower-risk, and best long-term solution.

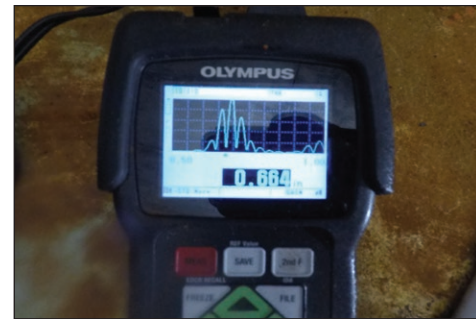
Figure 4. Ultrasonic thickness meter.

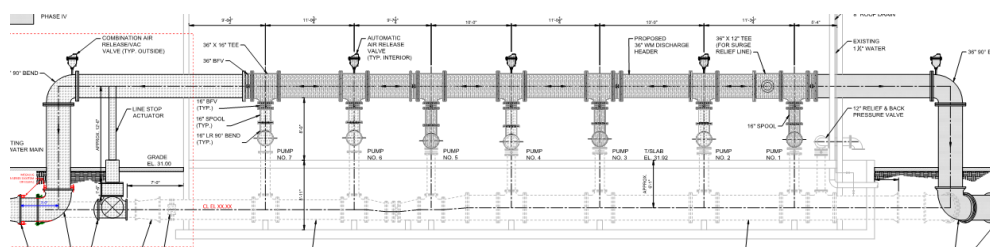
Figure 6. Replacement header draft layout.

Based on the initial agreed-upon layout (Figure 6), key items were established to be addressed in the design. The items have been grouped based on subject.

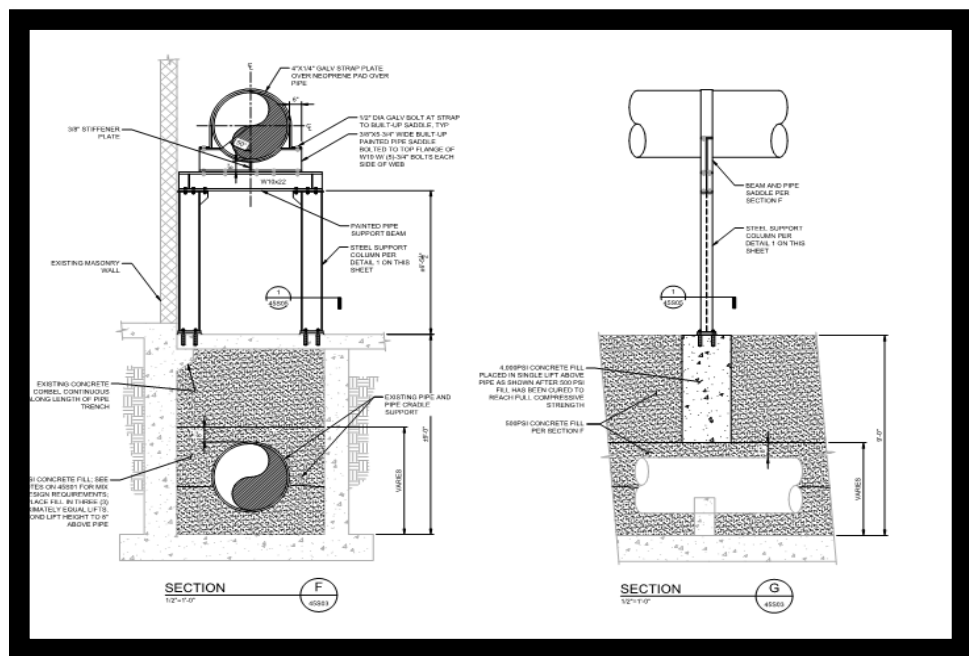
Figure 7. Structural encasement and new header pipe supports.

Based on the key items discussed, the most critical one was protecting the existing pipe. To provide support for the new header pipe, the column supports could not rest directly on the tunnel ceiling without providing more support below. Cutting out and accessing the tunnel was considered a risk to damaging the existing pipe; therefore, the tunnel was filled with concrete to protect the pipe, while also providing a base to build the new supports (Figure 7). Essentially, the existing header was “buried alive” while in service.

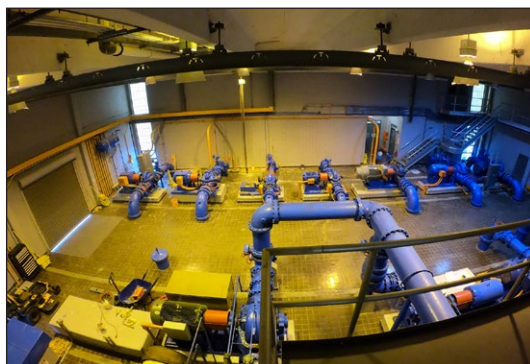
Figure 9. High-service pump station pump room prior to construction.

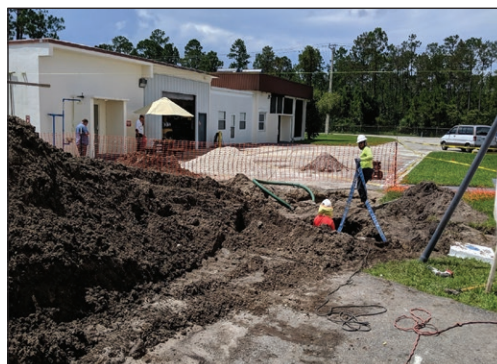
Figure 10. Phase 1 – Investigation.

Phase 1 began early in the project to prepare for the new header pipe (Figure 10). While this phase was the longest, the least amount of operational changes was required. The filling of the tunnel with concrete was the most important item in this phase to prepare for the new header pipe (Figure 11). To protect the existing header pipe, while minimizing settlement potential, a “lightweight” concrete mixture was used to fill the tunnel. It was well-planned, thoroughly discussed, and a success. With the header pipe encased, the tunnel was prepared for overhead construction of the new header pipe.

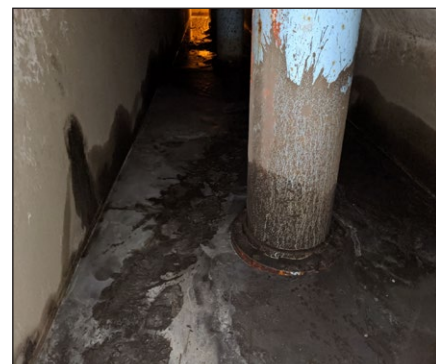
Figure 11. Phase 1 – Concrete fills the existing tunnel.

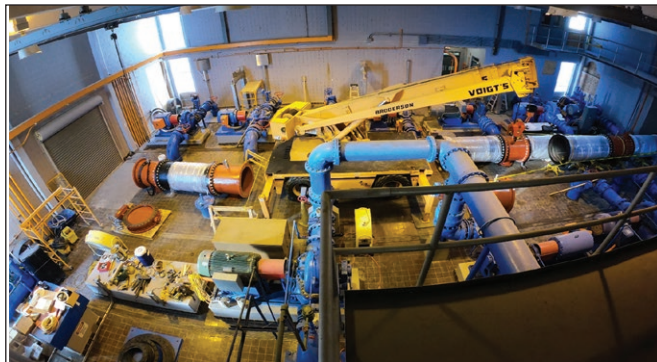
Figure 12. Phase 2 – Beginning of header pipe construction.

Phase 2 kicked off with the major equipment arrival (Figure 12), and the bulk of construction starting as the holiday season approached, adding yet another challenge to personnel. For this phase, the just-in-time delivery of key components (piping, valves,

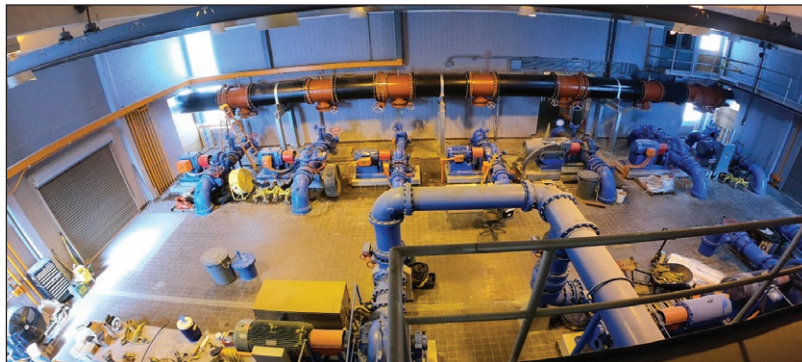
Figure 13. Phase 2 – Header pipe construction.

The greatest challenge in this phase was fabricating and installing the new piping overhead the existing HSPs, which were in active operation. The construction team proposed a construction method to fabricate the new header pipe, while minimizing risk to the operational pumps below (Figure 13). Special rigging equipment was implemented, including a 15-ton Broderson IB 200 carry deck crane, which was carefully placed in the middle of the HSPS room. As shown in the construction phasing photos, this was the key to safe installation of the pipe segments, while also maintaining operation.

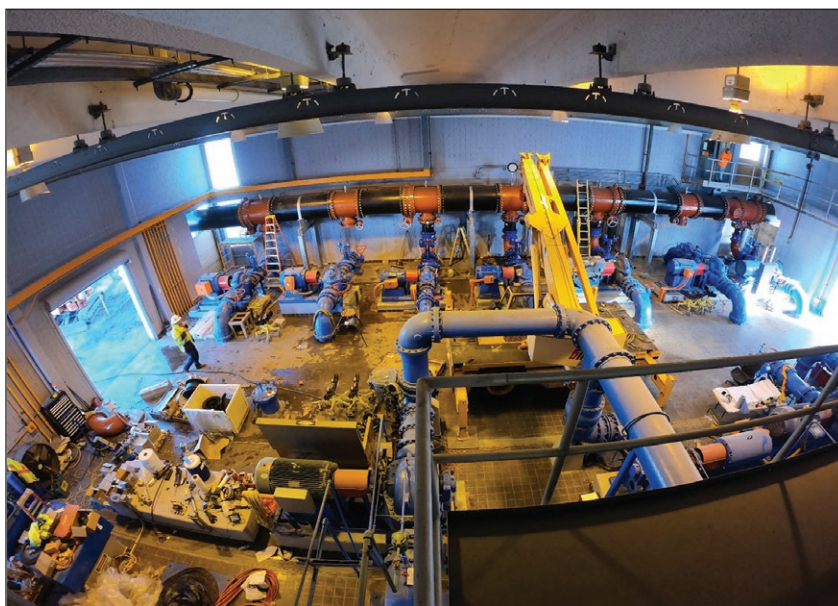
Figure 14.  
Phase 3 –  
Tie-in of  
pumps to  
header.

Phase 3 was viewed as the most critical in the project, where installation of a line stop in the active discharge header pipe was

required (Figures 14 and 15). If this were to fail, the entire city would be without water. For this reason, all hands were on deck. The city had a well-organized contingency plan in place. Additionally, the work occurred overnight, when water demands were at their lowest, for purposes of lowering velocities and pressures and minimizing the potential need of interconnects.

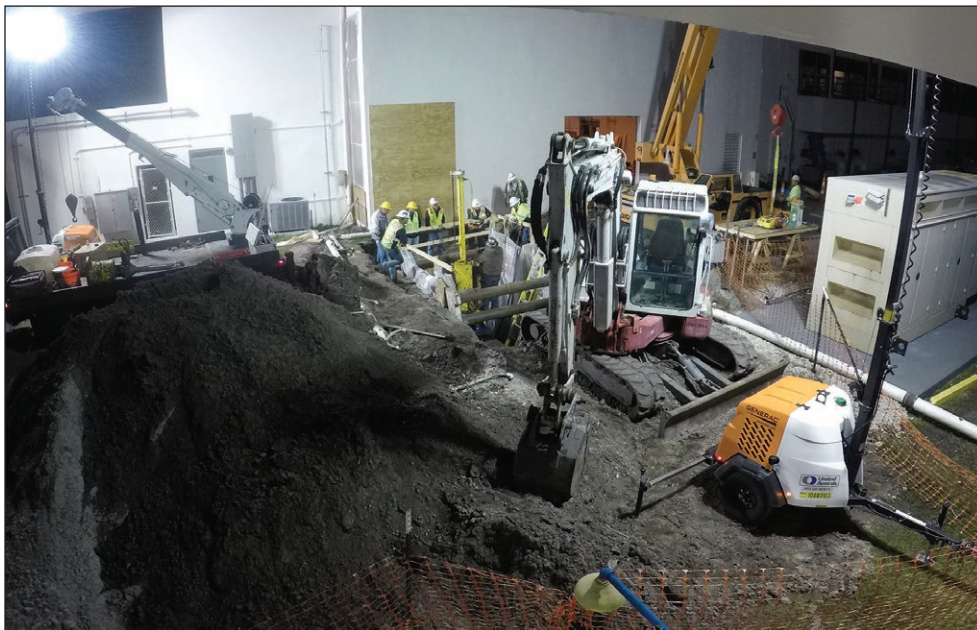
Figure 15. Phase 3 – Line stop at west discharge point.

The construction team had fully and safely prepared piping underground access, checked all piping restraints, and poured pipe supports and thrust rods in place. The line stop event was successfully completed, which allowed for the new header pipe to be connected into the existing west discharge main in the coming days. With the line stop and transition of pumps, both the old and new headers remained in service at the same time.

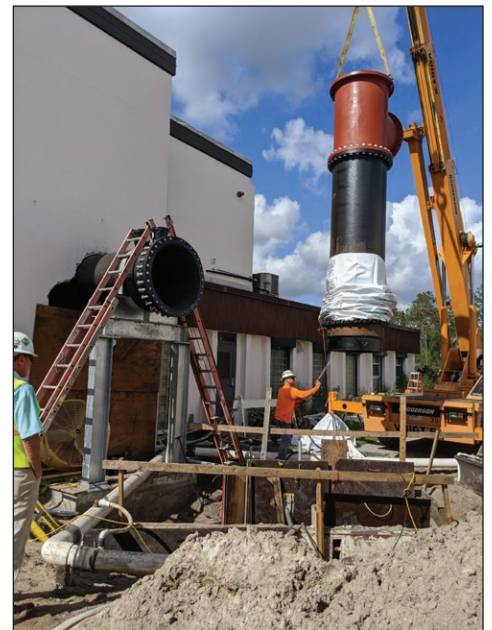
Figure 16. Phase 4 – Eastern tie-in.

Phase 4 followed, completing a similar tie-in on the east piping (Figure 16), but with the new header in service the old header could be isolated, so a line stop was not required.

This connection was a “measure twice, cut once” approach due to the alignment and rotation of the underground elbow. For this reason, extra piping and adapters were ordered; however, with proper planning, the piping dropped in as planned and the additional components were not required. Upon completion of Phase 4, substantial completion was achieved on schedule.

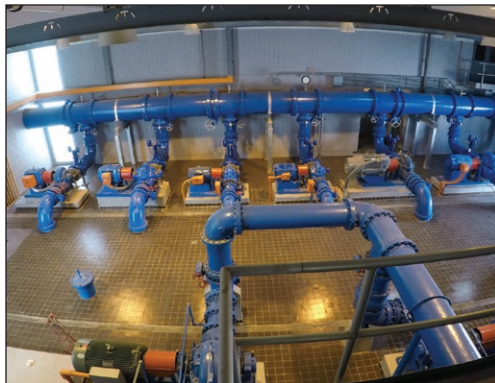
Figure 17. Phase 5 – Completion of the project.

Phase 5 included multiple wrap-up items, including painting, paving, and safety features (Figures 17, 18, and 19). This included some unforeseen challenges, including floor repair that required removal of brittle base/grout material that was installed during original construction, but given that there was now “pressure in the new pipe,” the pressure was off at this point.

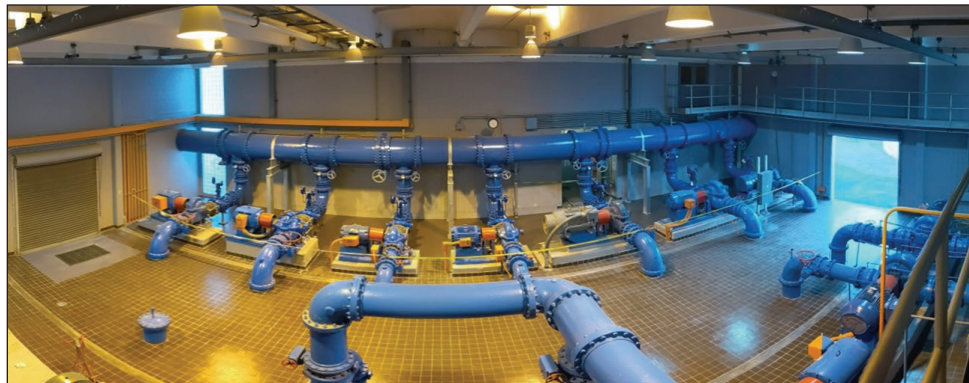
Figure 18. Phase 5 – Completion of the project (full view).

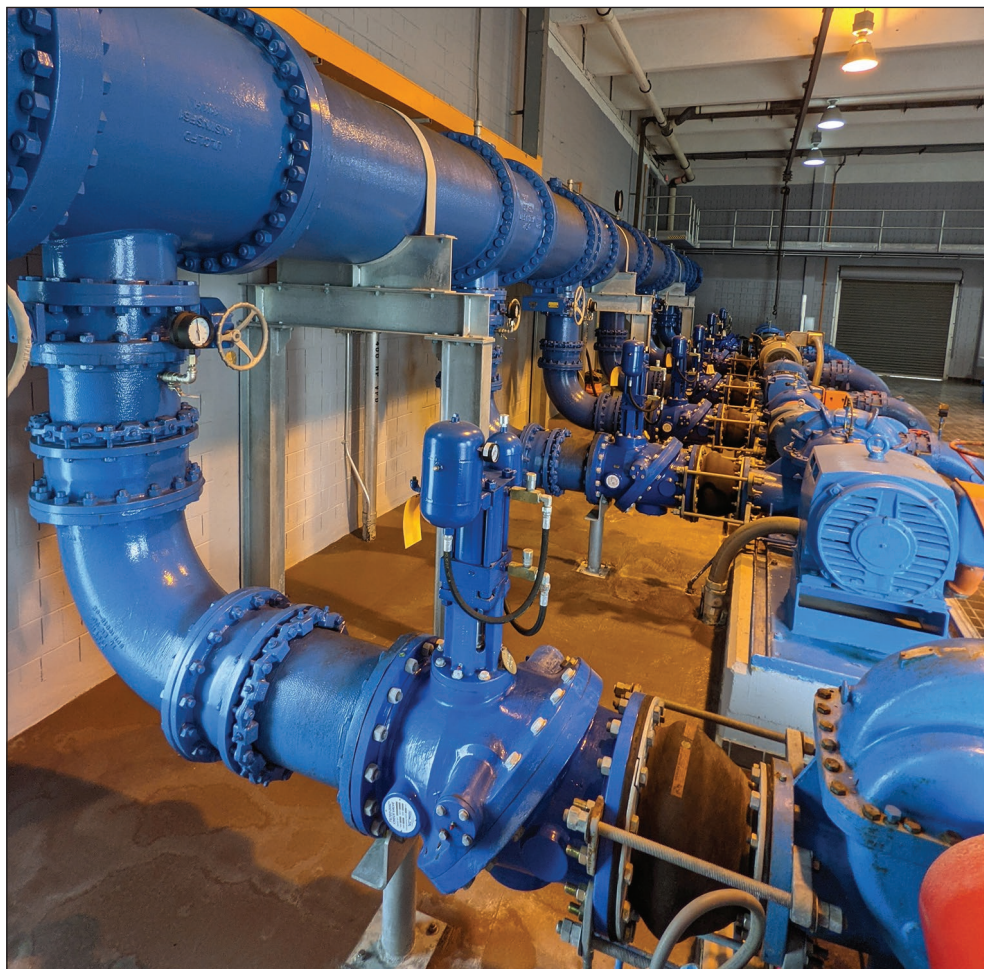
Figure 19. Phase 5 - Completion of the project (side view).
